STATE OF HAWAII
DEPARTMENT OF LAND AND NATURAL RESOURCES
Office of Conservation and Coastal Lands
Honolulu, Hawaii

CDUA: HA-3447

REGARDING: To Restore and Rebuild the 1893 "Nameless" Fishpond - Referred to as "Kapoho Fishpond"

LOCATION: Kapoho Bay, Kapoho Ahupuaa, Puna District, Island of Hawaii

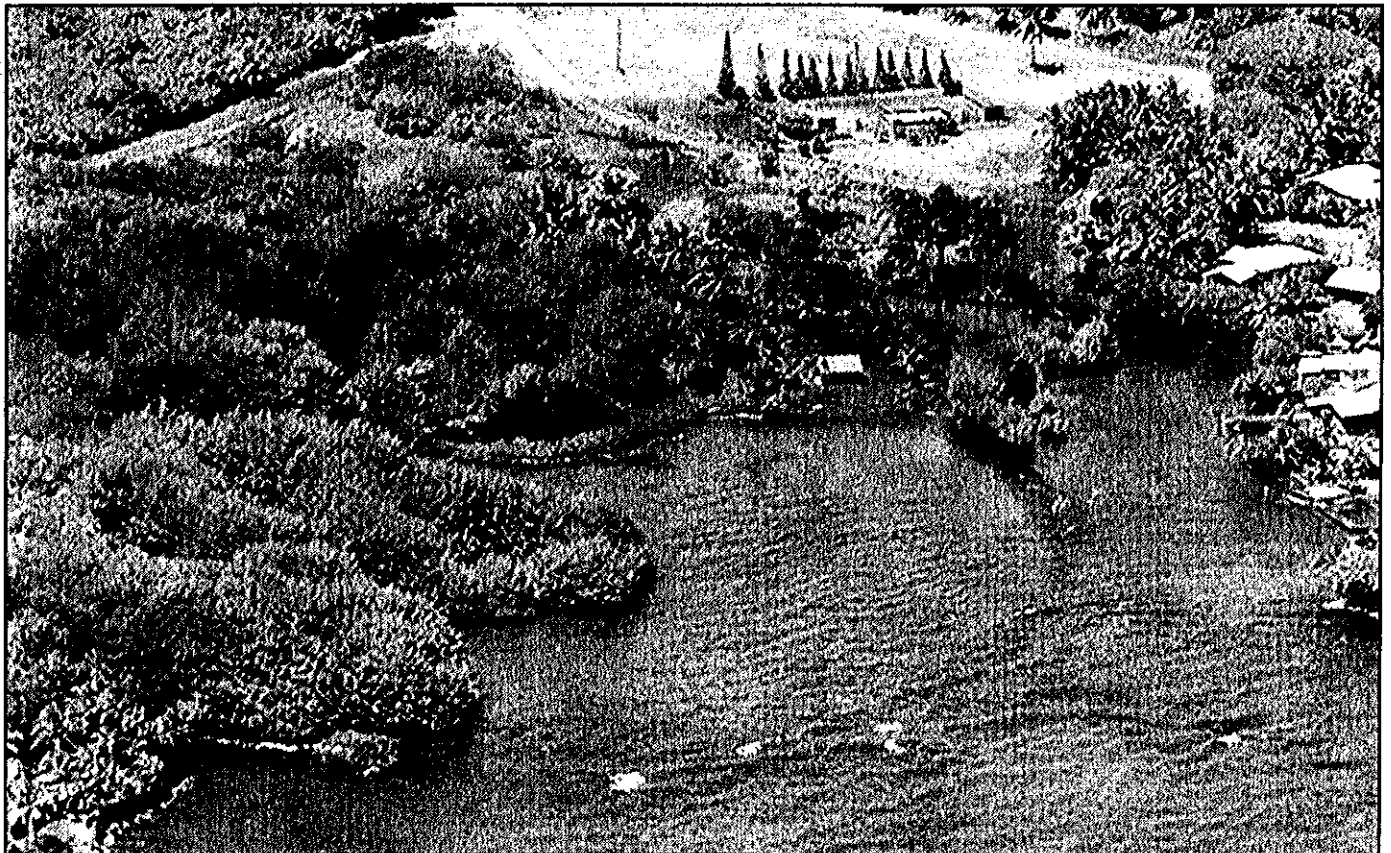
Figure 9. Aerial View of Kapoho Fishpond Circa 1970. Note intact wall and islets that are now covered in mangrove (Ford 1973).

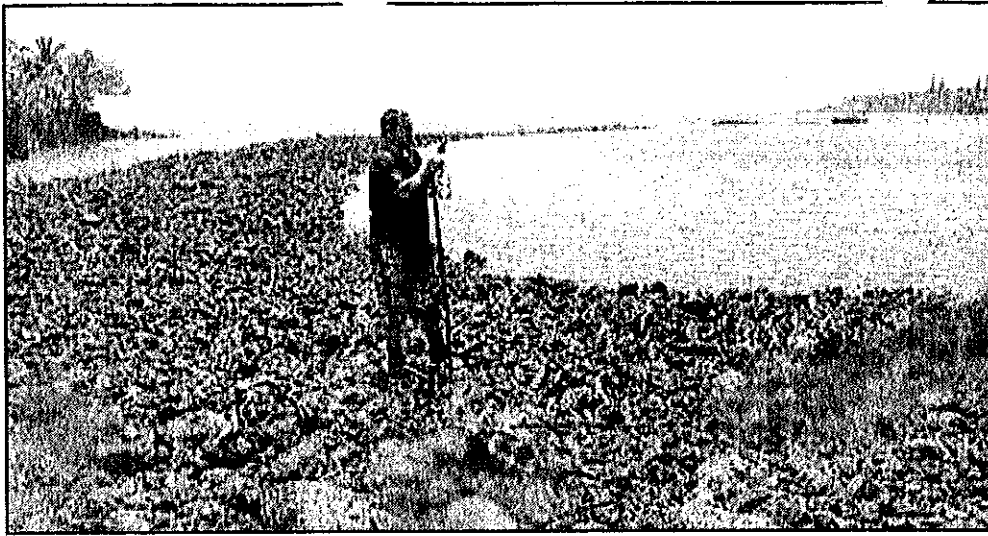
Fig 19. Beginning of Fishpond Wall at Northern End Where it Meets the Shoreline.

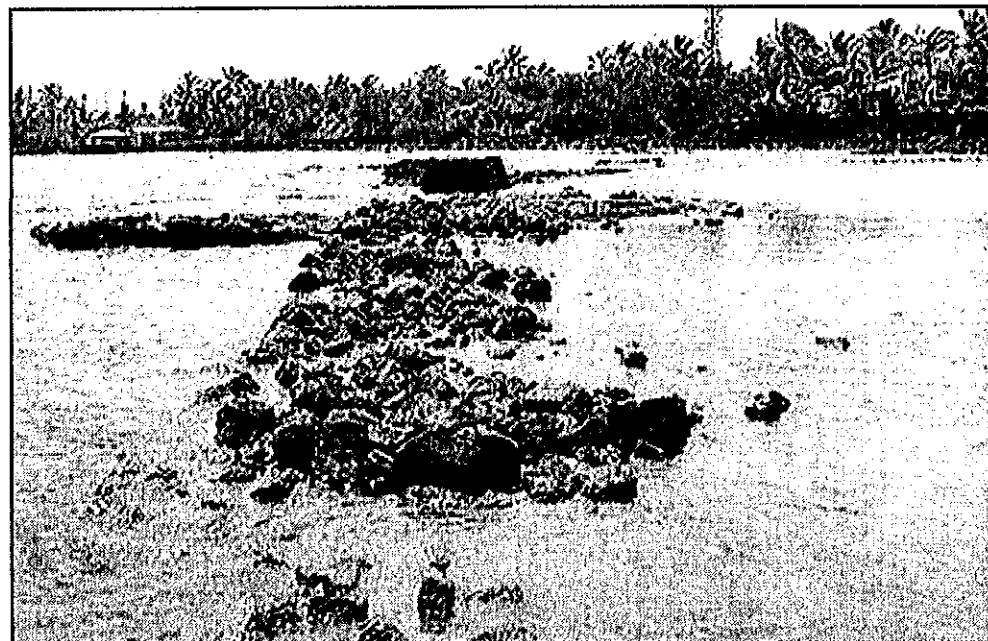
Figure 21. Wall with Makāhā in the Background. This Section of wall is exposed to high wave energy thus many of the wall stones are found inside the fishpond basin. The horizontal rock formation in the background right before the makaha is exposed reef.

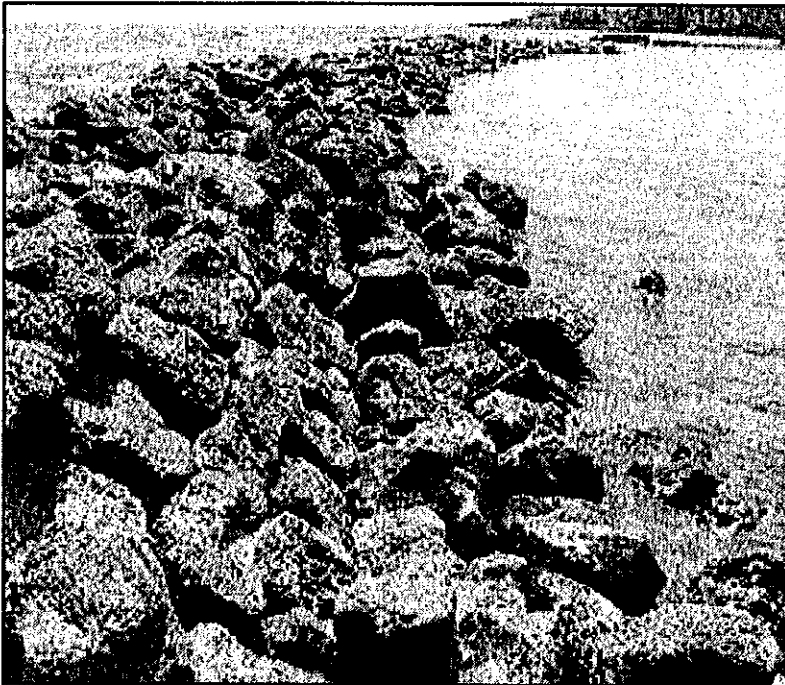
Figure 23, left, Inside Wall Facing. Inside wall alignment much less defined than outer wall. Many of the rocks have tumbled off the wall and are in the fishpond basin due to storm surges and wave action.

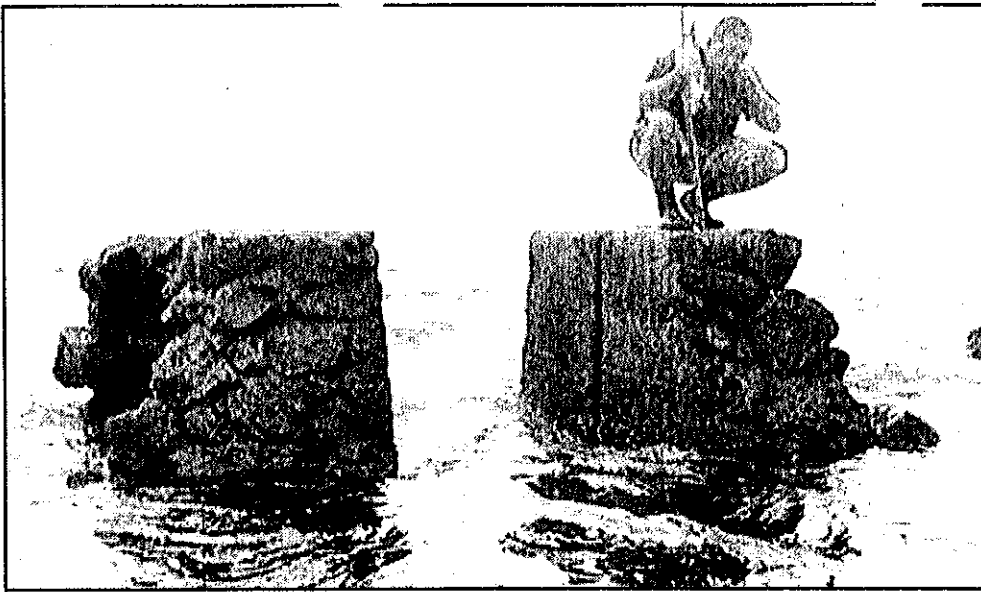
Fig 25. Mākāhā at Low Tide. Note at high tide mākāhā is completely submerged.

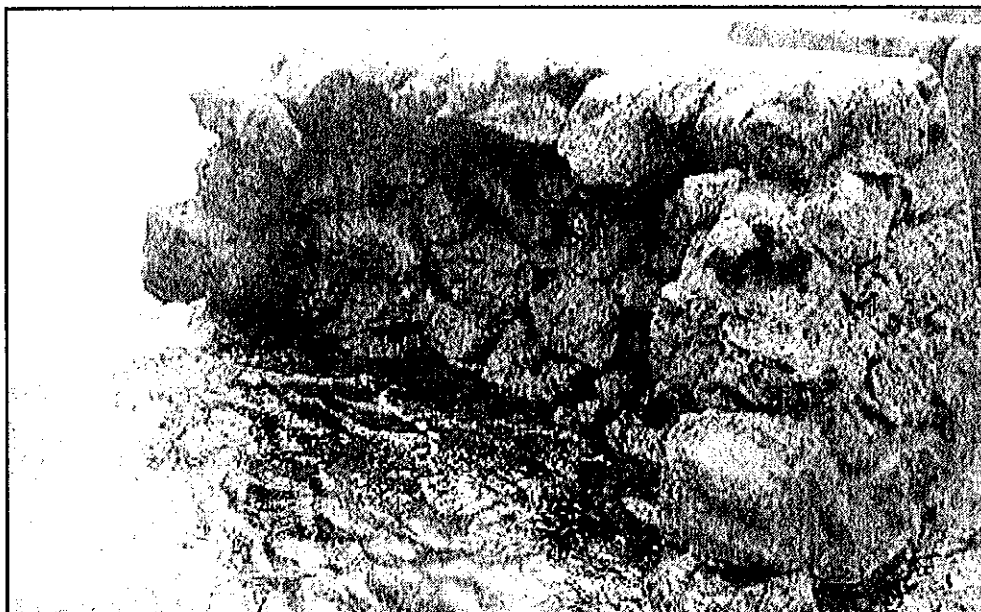
Figure 26. Detail of Northern Mākāhā.

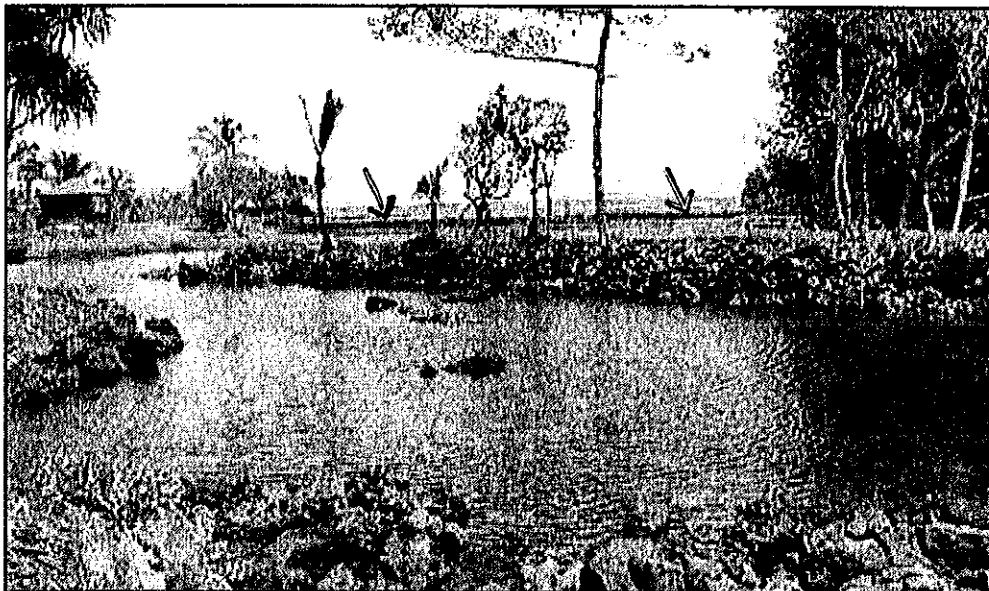
Figure 29. Interior of Fishpond Basin, North West Corner. The peninsula in the foreground has been cleared of heavy mangrove infestation. The fishpond wall is just visible in the background (arrows).

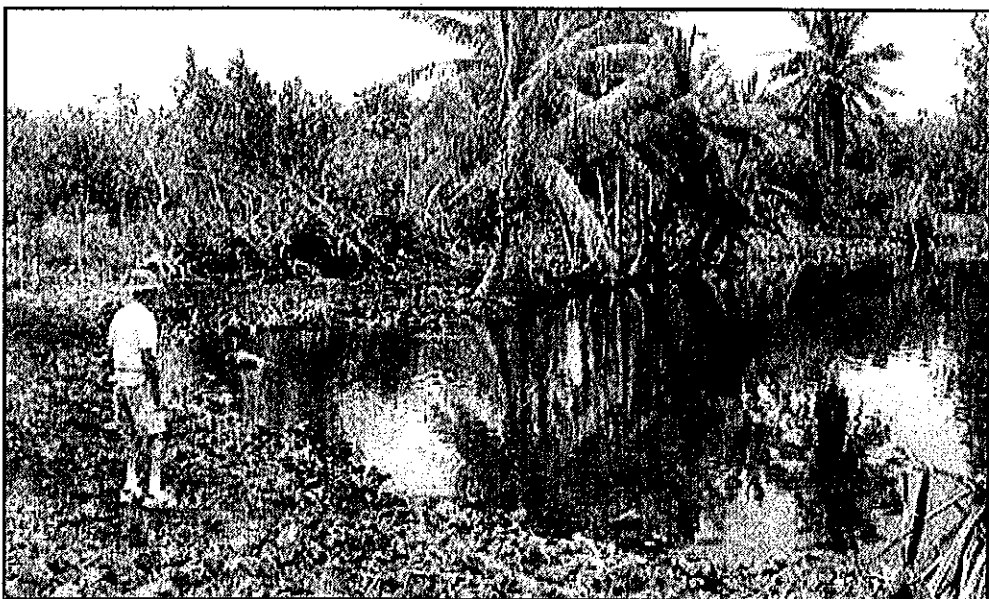
Figure 30. Back of Fishpond basin west end. Percolating springs are visible in this area of the fishpond basin. Note western property line delineated by chain link fence (right above gentleman's hat).
